2026-04-28

Sample Property Inspection Report

Sample Bangkok Condo

Unit Sample unit

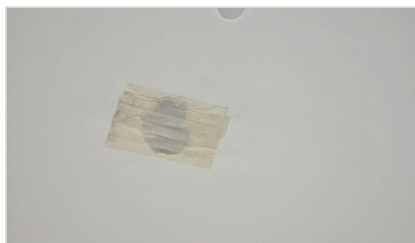
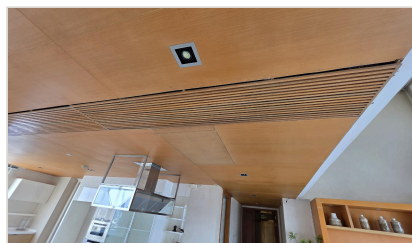
E-001

Living room: Removed light fixture left a noticeable hole in the ceiling, currently covered with tapes. Wooden ceiling in deteriorated condition	ROWS #019 EVIDENCE E-001, E-013
Second floor balcony bedroom: Flooring and wallpaper exhibited signs of water damage, likely due to flooding from neglected balcony drain.	ROWS #087 EVIDENCE E-002
Maid quarters bathroom: Significant leakage under the maid quarters sink.	ROWS #116 EVIDENCE E-007

Living room: ceiling condition

Living room: Ceiling condition
#019

FOLLOW-UP
Record repair follow-up

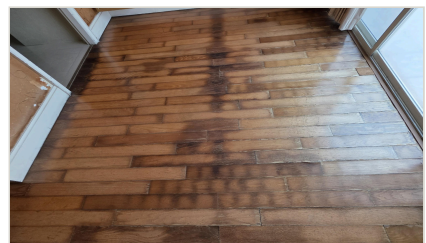
E-002

Second floor balcony bedroom: visible moisture or mold indicators

NO.	ITEM AND LOCATION	STATUS	EVIDENCE	FOLLOW-UP
278	<p>SECOND FLOOR BALCONY</p> <p>Second floor balcony: drain condition (BAL-SERVICE-BALCONY-DRAIN)</p> <p>Flooring and wallpaper exhibited signs of water damage, likely due to flooding from neglected balcony drain.</p>	Major issue	<p>E-002</p> <p>Visible water damage signs</p>	Review with plumber

Second floor balcony bedroom: Visible water damage signs
#087, #278

FOLLOW-UP
Review with plumber

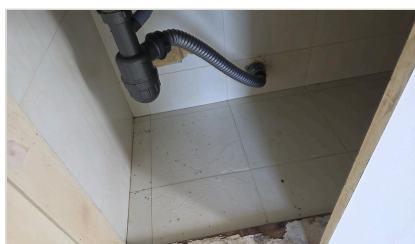
NO.	ITEM AND LOCATION	STATUS	EVIDENCE	FOLLOW-UP
116	MAID QUARTERS BATHROOM Maid quarters bathroom: under-sink cabinet and visible plumbing (BATH-BATHROOM-2-UNDER-SINK) Significant leakage under the maid quarters sink.	Major issue	E-007 Under-sink inspection	Review repair or replacement with plumber

NO.	ITEM AND LOCATION	STATUS	EVIDENCE	FOLLOW-UP
164	<p>MAID QUARTERS SINK</p> <p>Maid quarters sink: visible leaks at connection (WATER-MAID-QUARTERS-SINK-LEAK)</p> <p>Significant leakage under the maid quarters sink.</p>	Major issue	<p>E-007</p> <p>Under-sink inspection</p>	Review repair or replacement with plumber

Maid quarters: Under-sink inspection
#116, #164

FOLLOW-UP
Review repair or replacement with plumber

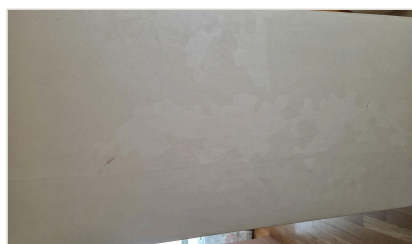
NO.	ITEM AND LOCATION	STATUS	EVIDENCE	FOLLOW-UP
018	LIVING ROOM Living room: visible wall condition (ROOM-LIVING-ROOM-WALLS) Damaged wallpaper throughout the unit, well within expectation for a unit of this age.	Minor issue	E-005 Wall cracks	Record repair or replacement follow-up
019	LIVING ROOM Living room: ceiling condition (ROOM-LIVING-ROOM-CEILING) Removed light fixture left a noticeable hole in the ceiling, currently covered with tapes. Wooden ceiling in deteriorated condition	Major issue	E-001 E-013 Ceiling condition; Ceiling condition	Record repair follow-up
020	LIVING ROOM Living room: floor surface and visible level (ROOM-LIVING-ROOM-FLOOR) No issue recorded during the field check.	OK	Completed field check: room-floor	No action
087	SECOND FLOOR BALCONY BEDROOM Second floor balcony bedroom: visible moisture or mold indicators (ROOM-SECOND-FLOOR-BALCONY-BEDROOM-MOISTURE) Flooring and wallpaper exhibited signs of water damage, likely due to flooding from neglected balcony drain.	Major issue	E-002 Visible water damage signs	Review with plumber

Throughout the unit: Wall cracks
#018
